# A Risk-Based Approach to Assessing Asset Performance of Flood Infrastructure

George Arthur Bowman,  
Asset BowManagement Ltd  
New Zealand

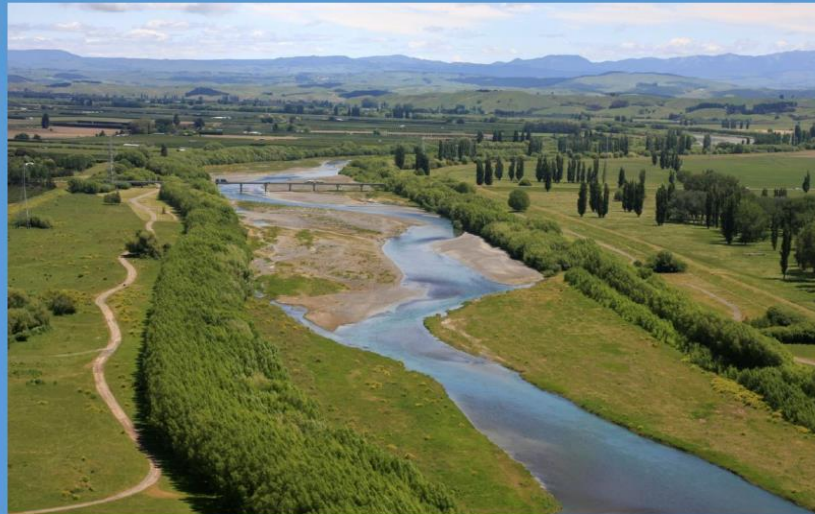
## Flood Protection Assets Performance Assessment Code of Practice

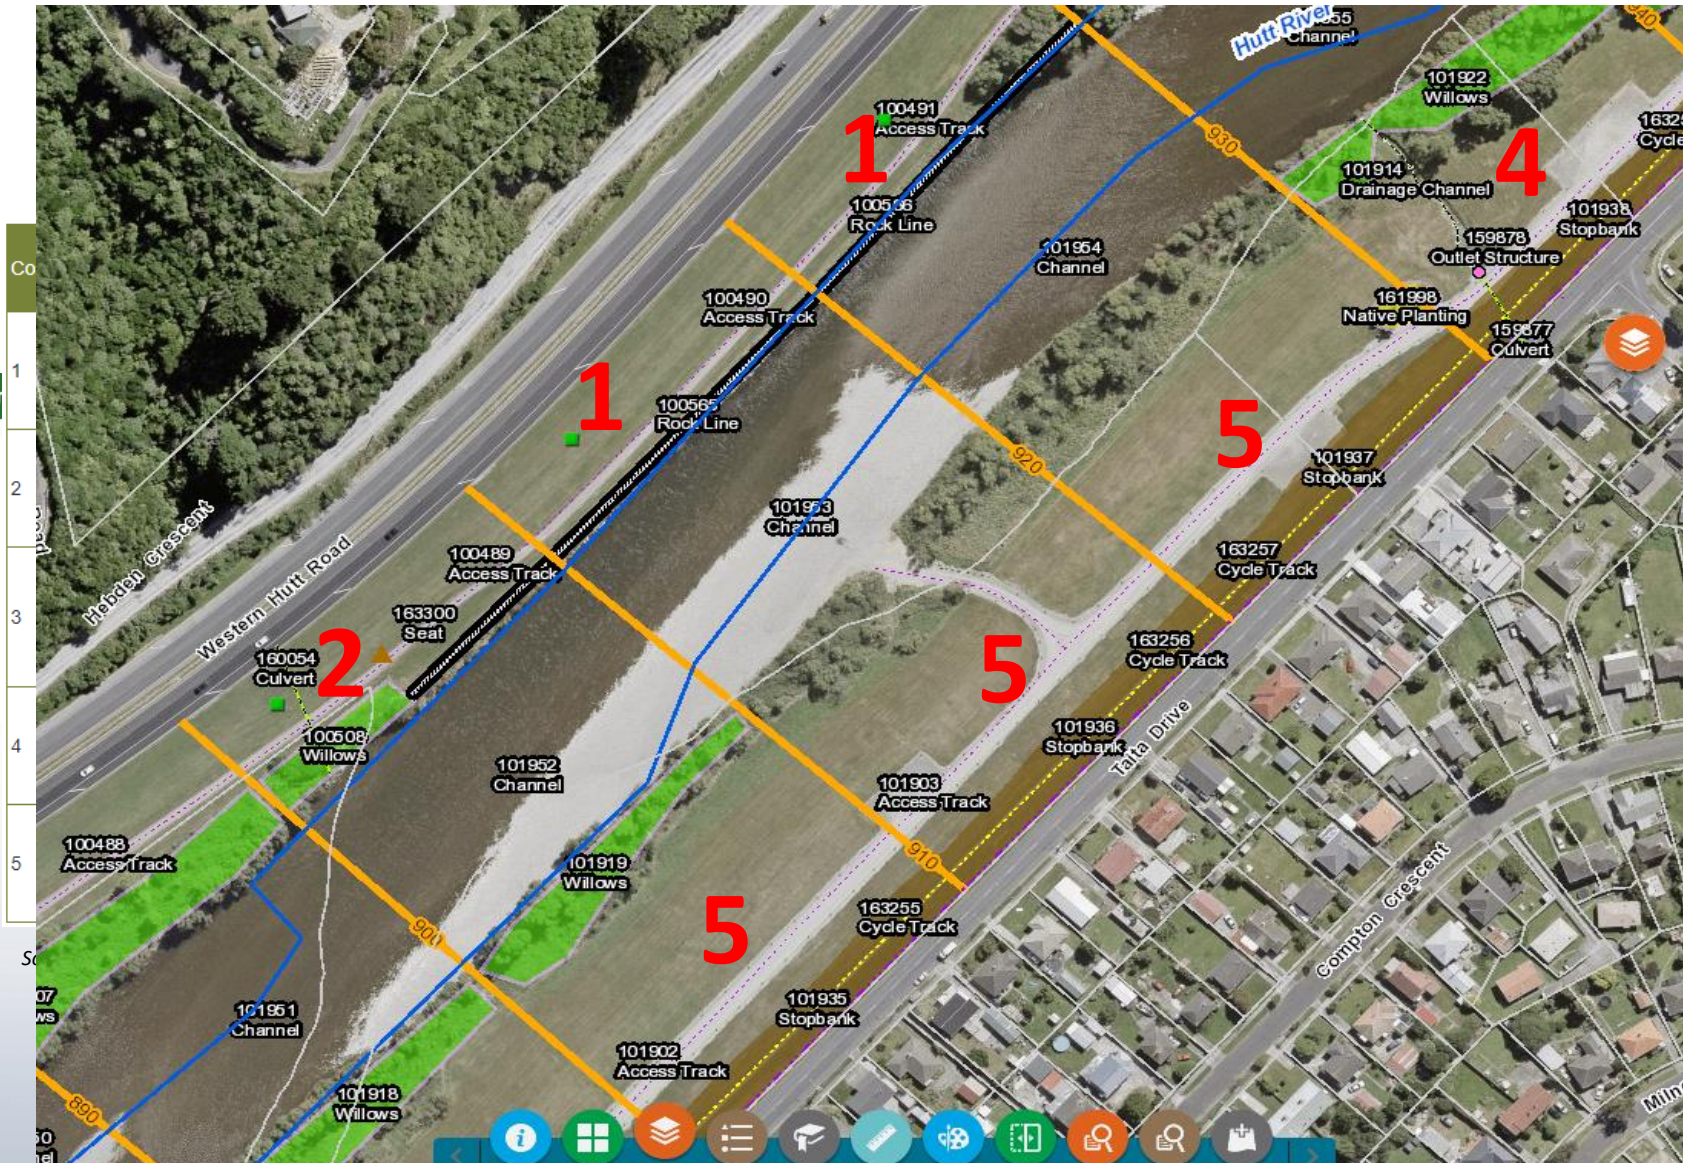
# Methodology

## CONSEQUENCE

Modelling  
Breach Analysis  
Flood Hazard Maps

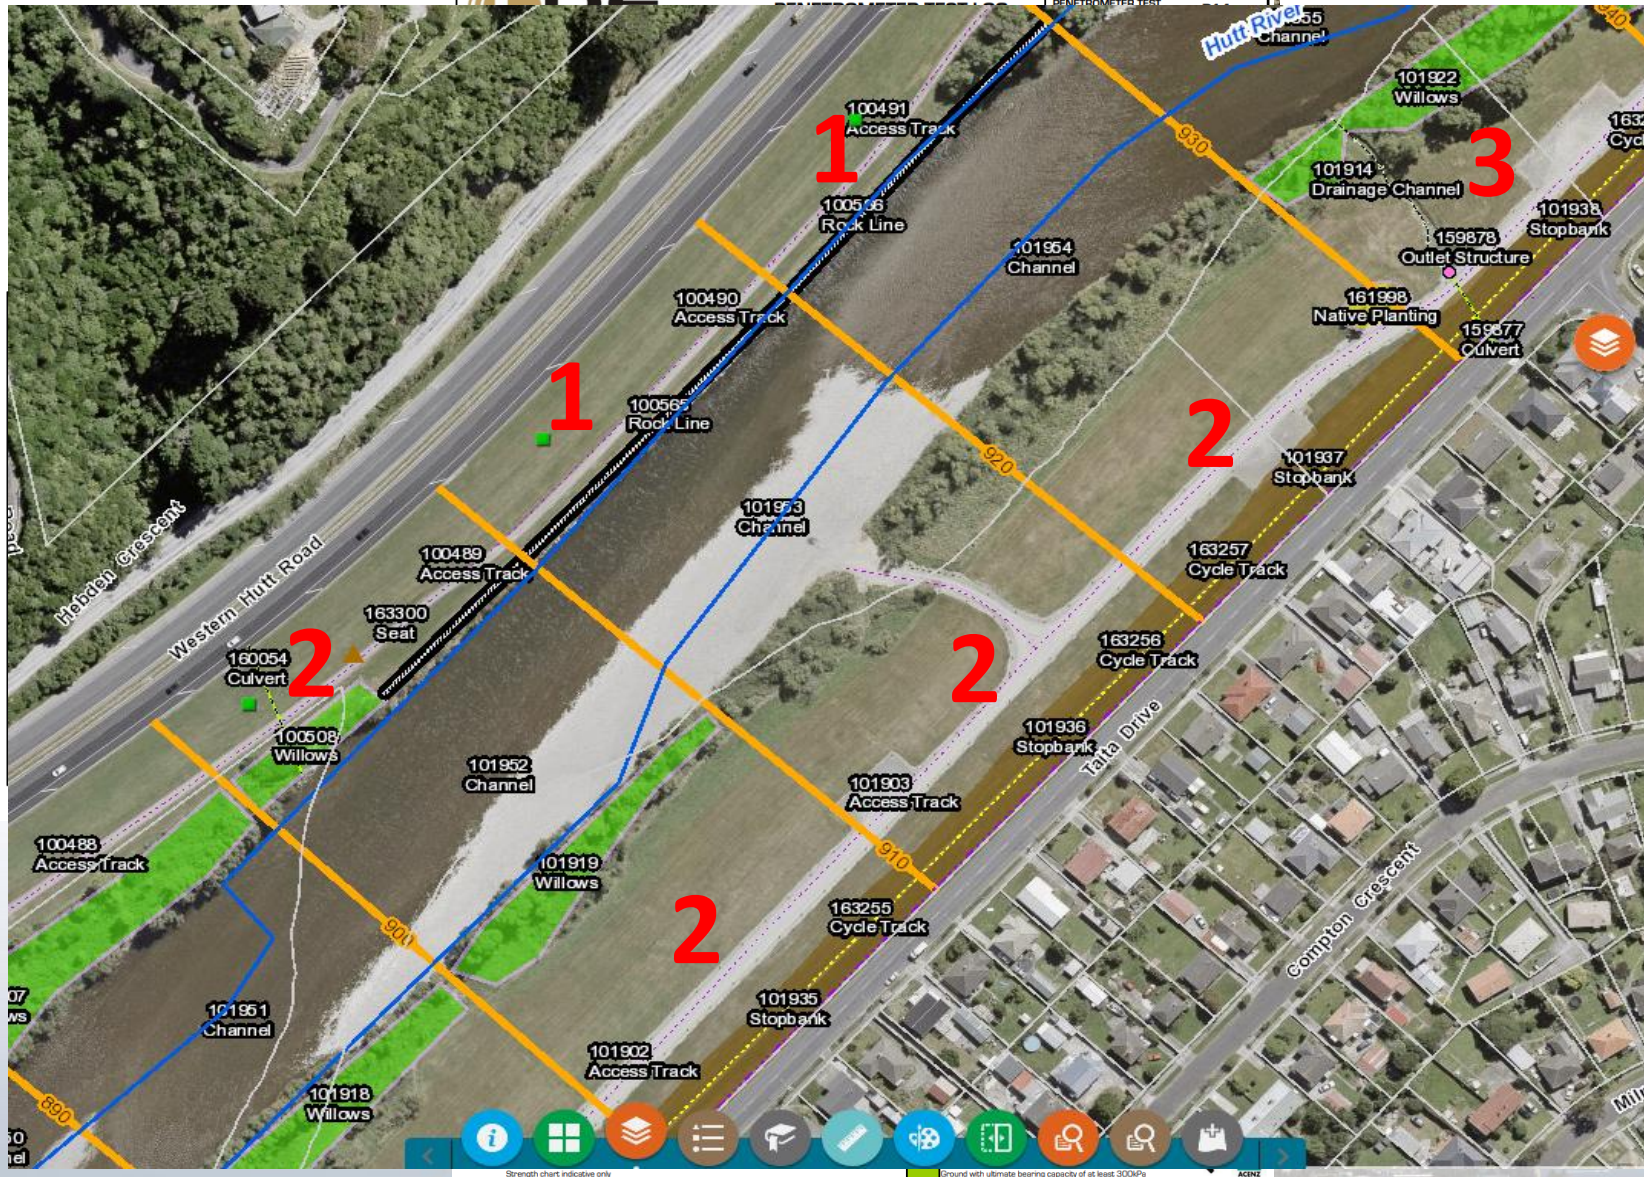
# Methodology

PROBABILITY

INTRINSIC  
STRENGTH

Geotech  
Investigation  
As-builts

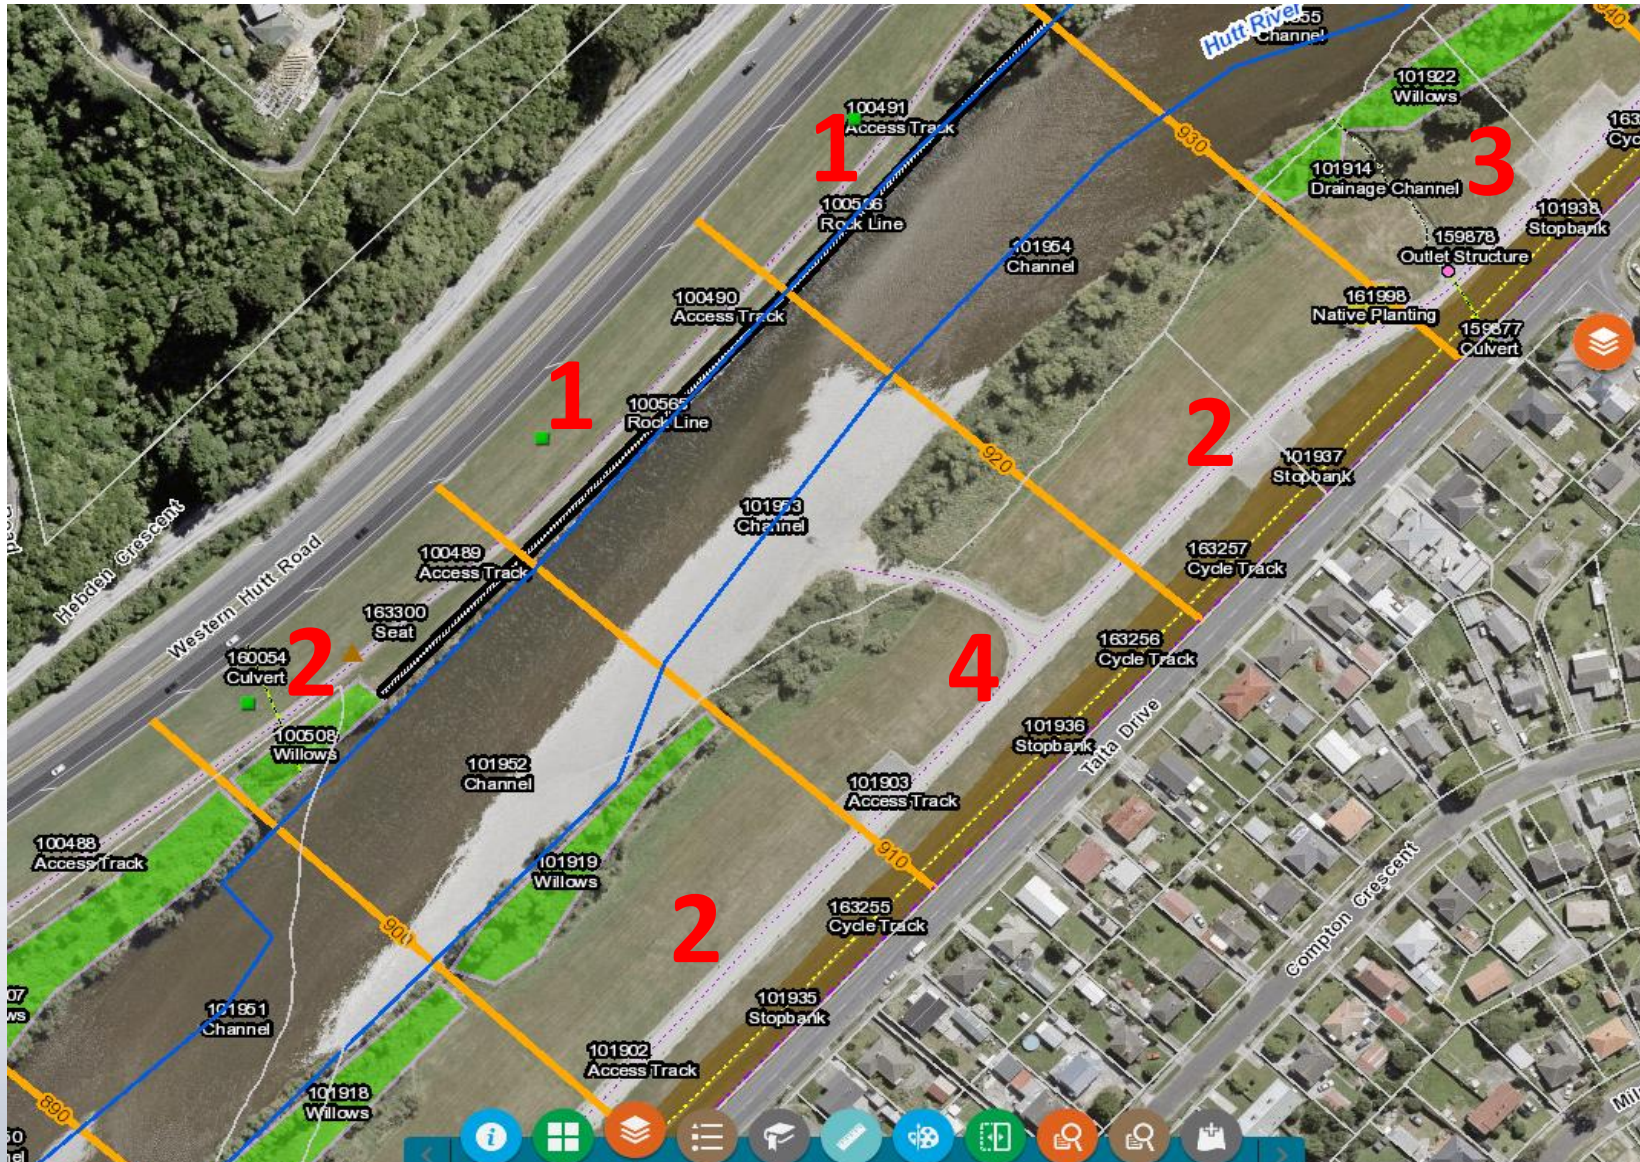
# Methodology

PROBABILITY

CONDITION

Inspections  
Assessment  
Desktop

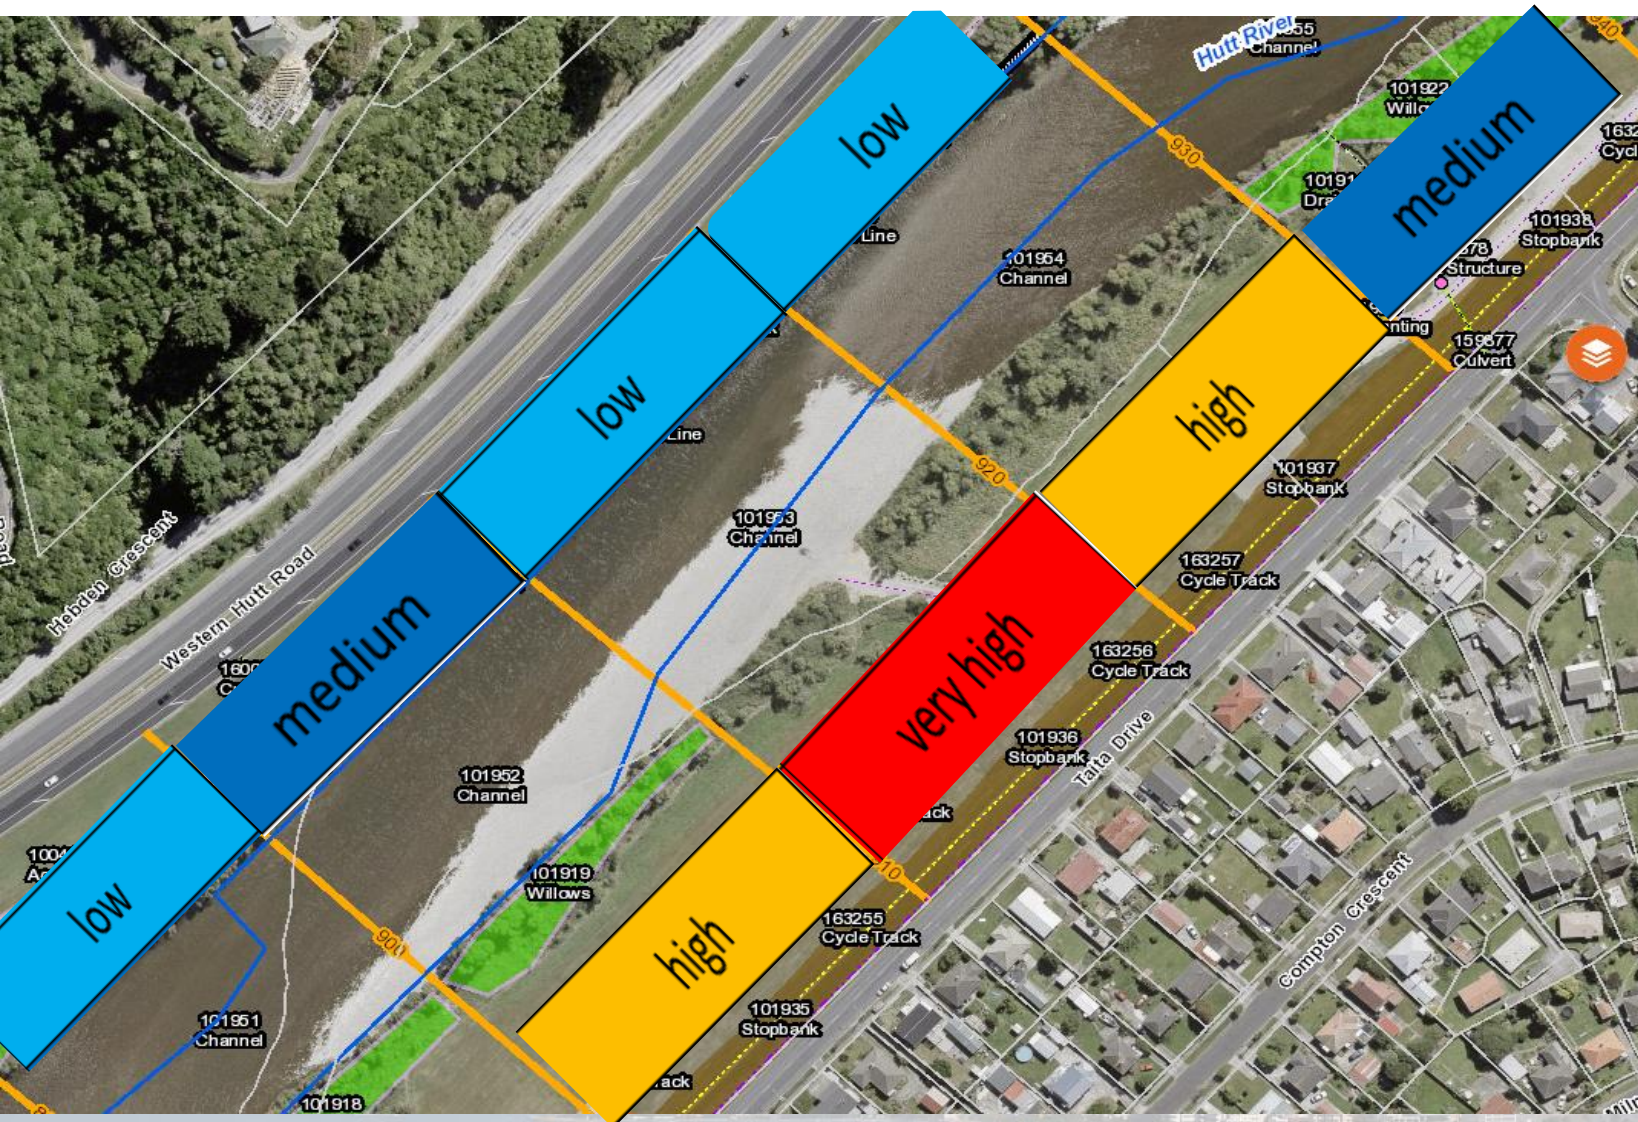
# Results

| | | Probability | | | | |
| Consequence | 1 | very low | very low | low | medium | medium |
